**Flood Control Project Maintenance
Levee Inspections**
LMA District Cover Sheet
Spring 2019 Levee Inspection Results

Reclamation District No. 0784 Plumas Lake

Spring 2019 Levee Inspection Results

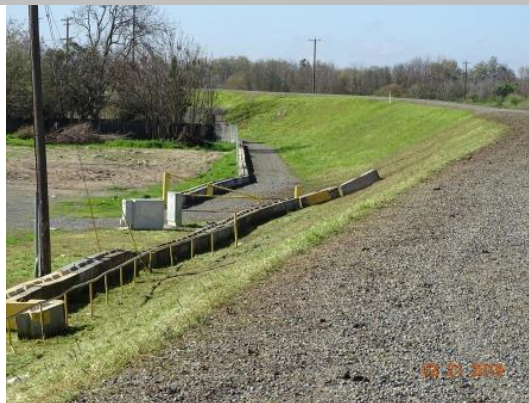
Photo 1 of 1 : SP_2019_RD0784_178_2_20190325_00008.jpg

View looking downstream landside at the well maintained annual vegetation, Spring 2019.

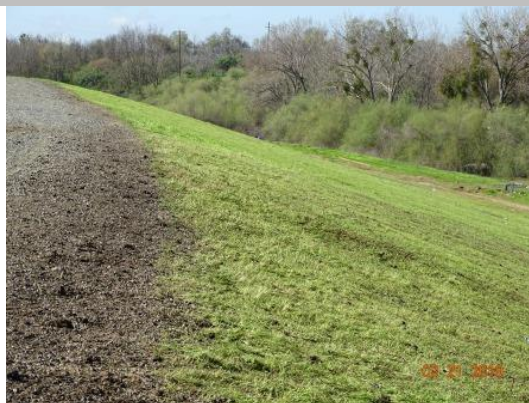
Photo 1 of 1 : SP_2019_RD0784_178_3_20190325_00009.jpg

LM Start	0.04	Rating **	A	Issue No.	3
LM End	2.21	Issue Type +	Ma	Location *	WS
Category	Earthen Levee			GPS Latitude/Longitude	
				Start	End
Item	Vegetation			39.134430 °	39.125800 °
				-121.552686 °	-121.588658 °
DWR ID	DWR_RD0784_01_s_2019_3				
Comment Code					
V1 : Control annual grass and weeds on the levee slopes and easements.					
Inspector Comment					
The annual vegetation is well maintained, Spring 2019.

View looking downstream waterside at the well maintained annual vegetation, Spring 2019.

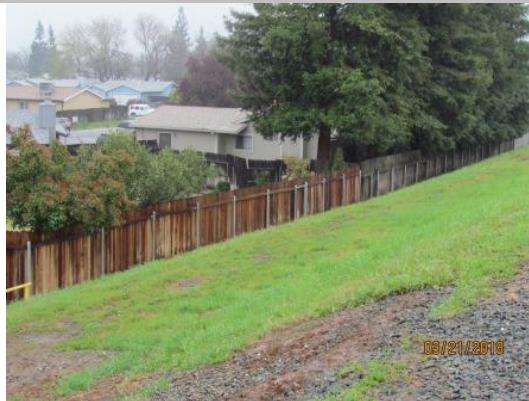
Photo 1 of 1 : SP_2019_RD0784_178_12_20190305_00001.jpg

LM Start	0.51	Rating **	U	Issue No.	12
LM End	1.00	Issue Type +	En	Location *	LS
Category	Earthen Levee			GPS Latitude/Longitude	
				Start	End
Item	Encroachments			39.131558 °	39.129475 °
				-121.560668 °	-121.569209 °
DWR ID	DWR_RD0784_01_f_2012_12				
Comment Code					
FE : Fence					
Inspector Comment					
Fences are found within the 10 feet of levee easement.

View looking downstream landside of fences that are found on the landside toe of the levee looking downstream.

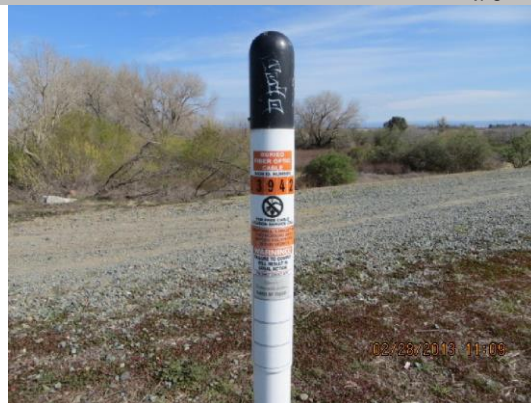
Photo 1 of 3 : UCIP_SP_2019_50677_54402.jpg

Comment Code						
Inspector Comment						
FS_ID:50677 DS_ID:18552 EP_NO: N/A Repair Type: Non-Urgent Crossing Status: Indicator Found UCIP Comments: 11/15/2016 - Crossing is still Non-Urgent due to the possibility that the pipe is unpermitted. The crossing will be downgraded when owner provides permit or CVFPB enforcement resolves the issue. (DWR UCIP - thatch)11/01/2015 - Letter requesting permit or to provide permit sent to owner Century Link, 700 W. Mineral Avenue, Rm D 27.34, Littleton, CO 80120 on 2/18/2014. Pending CVFPB enforcement on utility crossing owner. Requesting DWR inspector to change the status of this issue to "No Action Needed" (P. Meagher - RD784) 02/28/2013 - No permit identified for this crossing. Need to determine if owner has permit. (W.Wylie UCIP Inspector). FIELD_STRUCT_DESC: Fiber optics communications lines of an unknown material and diameter through the levee, at an unknown depth. [Additional Reference(s): DWR Levee Log, 2005]. FS Date: 9/11/2015 9:08:00 AM

Marker on east side of Rail/WS of Levee.

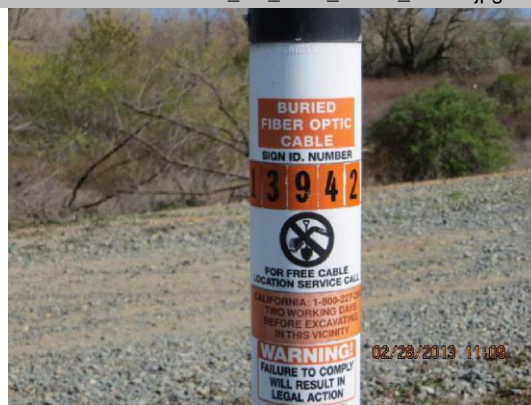
Photo 2 of 3 : UCIP_SP_2019_50677_54401.jpg

Marker on east side of Rail/WS of Levee.

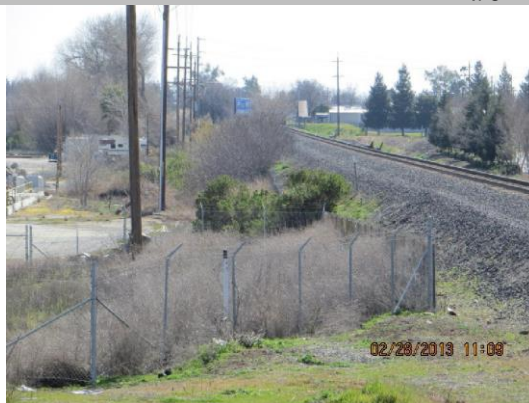
Photo 3 of 3 : UCIP_SP_2019_50677_54400.jpg

Comment Code						
Inspector Comment						
FS_ID:50677 DS_ID:18552 EP_NO: N/A Repair Type: Non-Urgent Crossing Status: Indicator Found UCIP Comments: 11/15/2016 - Crossing is still Non-Urgent due to the possibility that the pipe is unpermitted. The crossing will be downgraded when owner provides permit or CVFPB enforcement resolves the issue. (DWR UCIP - thatch)11/01/2015 - Letter requesting permit or to provide permit sent to owner Century Link, 700 W. Mineral Avenue, Rm D 27.34, Littleton, CO 80120 on 2/18/2014. Pending CVFPB enforcement on utility crossing owner. Requesting DWR inspector to change the status of this issue to "No Action Needed" (P. Meagher - RD784) 02/28/2013 - No permit identified for this crossing. Need to determine if owner has permit. (W.Wylie UCIP Inspector). FIELD_STRUCT_DESC: Fiber optics communications lines of an unknown material and diameter through the levee, at an unknown depth. [Additional Reference(s): DWR Levee Log, 2005]. FS Date: 9/11/2015 9:08:00 AM

Marker on East side of Rail/LS of levee.

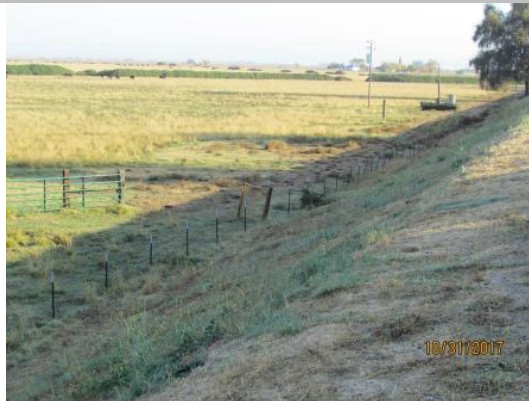
Photo 1 of 1 : SP_2019_RD0784_534_7_20190305_00001.jpg

View looking upstream landside of a fence that is at the levee toe.

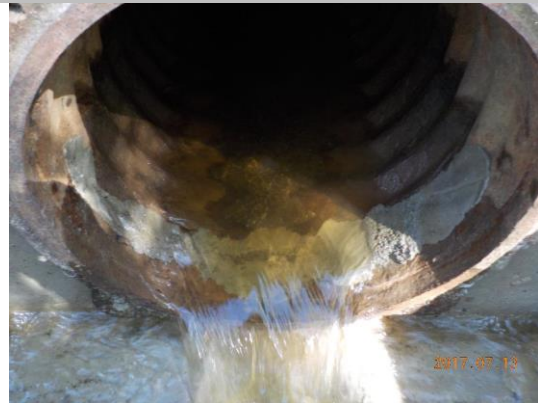
Photo 1 of 3 : UCIP_SP_2019_53072_77114.jpg

UCIP Comments: 10/16/2018 Internal video inspection was completed recently and the inspection is being evaluated by the District Engineer. Waiting for internal inspection results to determine the internal condition of this crossing. Crossing remains Urgent due to the unknown condition of the pipe through the levee. (O. Magana - DWR UCIP) 11/30/2017 Crossing remains Urgent due to uncertainty of pipe condition through levee -- recommend an internal inspection of the pipe through the levee as a precaution measure to determine integrity of pipe. Repair of the rusted out collar (void) found at the WS pipe outlet has been repaired by the LMA. Received additional photos from DWR levee inspector, S. York, of the WS concrete headwall installed and vegetation cleared from WS. (O. Magana - DWR UCIP)07/13/2017 - The rusted out collar at the bottom of the waterside flap gate has been sealed with concrete. Internal pipe inspections still pending. (P.Meagher-RD784).04/13/2017 - Spoke to LMA representative, P. Meagher, regarding the status of this crossing. The report has been updated to indicate vegetation has been cleared from WS outlet and LS inlet. The crossing remains Urgent--WS pipe collar is rusted out on the bottom. Recommend internal pipe inspection to determine pipe integrity through the levee. Owner will need to coordinate with the CVFPB to address issue. (O. Magana - DWR UCIP) 01/16/2017 - Landowner who utilizes this pipe reported to RD784 staff on 1/11/2017 that he suspected this pipe at the waterside flap gate ring area was rusted out at the bottom. After investigating, we could see what was reported is correct. Sandbags have been temporarily placed around the 2" +/- gapped area underneath the flap gate ring. A permanent solution is anticipated to be completed in the next 3 to 6 months. The plan is to pour a concrete ring / headwall around the open corroded pipe end. Photos attached. (P. Meagher - RD784).11/04/2016 - Flap gate on waterside has been cleared again as of 10/17/2016. The LS inlet area has been cleared as of 9/21/2016. See updated photos attached. (P.Meagher - RD784)09/22/2016 - vegetation at inlet of pipe has been cleared by owner. photos added showing pipe inlet. (T. Hatch - DWR UCIP)08/09/2016 - vegetation partially obscuring outlet on WS. Heavy vegetation on landside (LS) limiting inspection of inlet. Owner asked by RD0784 to clear vegetation and debris. (T. Hatch - DWR UCIP)11/1/2015 - Flap Gate has been cleared as of 12/9/2014 and again during summer of 2015 (P. Meagher/RD0784)2/27/2013 - Flap gate blocked by vegetation on WS toe. Unable to locate inlet. (W. Wylie - DWR UCIP)

Close up photo of concrete seal where the rusted out void used to be. Farmer irrigation was currently flowing at the time the photo was taken.

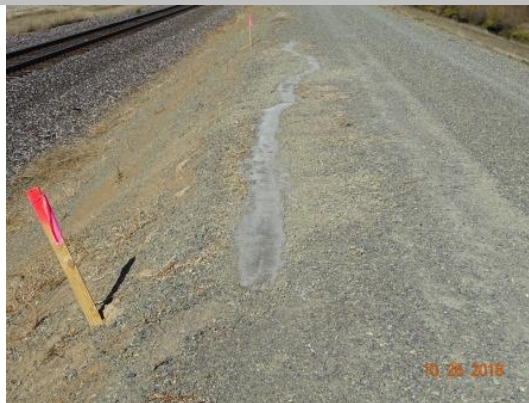
Photo 1 of 1 : SP_2019_RD0784_181_4_20190305_00001.jpg

LM Start	1.09	Rating **	A/W	Issue No.	4
LM End	1.09	Issue Type +	Ob	Location *	CR
Category	Earthen Levee			GPS Latitude/Longitude	
				Start	End
Item	Cracking			38.990383 °	38.990383 °
				-121.538051 °	-121.538051 °
DWR ID	DWR_RD0784_04_f_2018_4				
Comment Code					
CR1 : Monitor and have inspected by geotechnical engineer.					
Inspector Comment					
Lineal cracking on the crown has been repaired but needs to be monitored through the rainy season, Fall 2018.

View looking upstream on the crown of lineal cracking that has been repaired, Fall 2018.

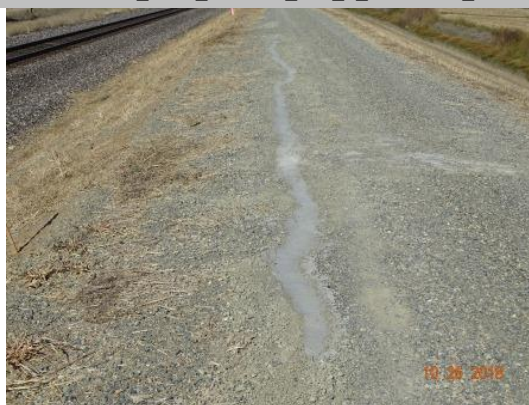
Photo 1 of 1 : SP_2019_RD0784_181_5_20190305_00002.jpg

LM Start	1.61	Rating **	A/W	Issue No.	5
LM End	1.61	Issue Type +	Ob	Location *	CR
Category	Earthen Levee			GPS Latitude/Longitude	
				Start	End
Item	Cracking			38.997839 °	38.997839 °
				-121.539477 °	-121.539477 °
DWR ID	DWR_RD0784_04_f_2018_5				
Comment Code					
CR1 : Monitor and have inspected by geotechnical engineer.					
Inspector Comment					
Lineal cracking on the crown has been repaired but needs to be monitored through the rainy season, Fall 2018.

View looking upstream on the crown of lineal cracking that has been repaired, Fall 2018.

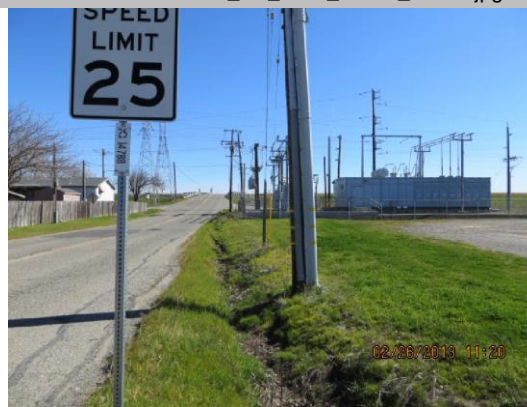
Photo 2 of 3 : UCIP_SP_2019_46600_54243.jpg

Communication line runs on south side of Plumas Arboga Road to JP approximately 400-feet West of levee crown.

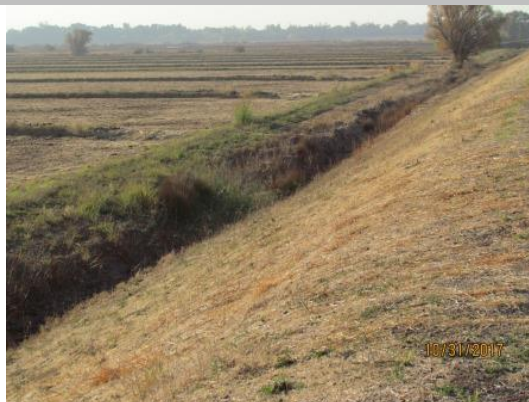
Photo 1 of 1 : SP_2019_RD0784_182_10_20190305_00003.jpg

View of landside looking downstream at the ditch that is along the levee toe. Fall 2017.

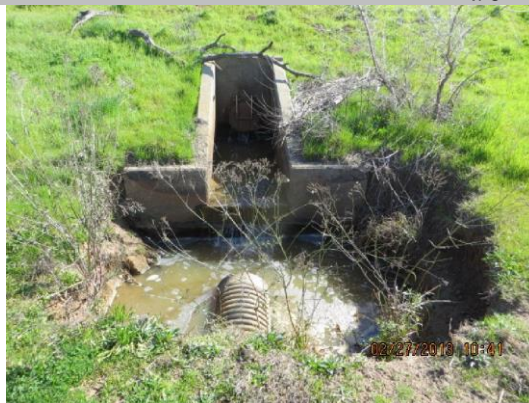
Photo 2 of 3 : UCIP_SP_2019_53557_54253.jpg

Concrete U-shaped headwall on WS toe with Flap gate showing erosion at outlet.

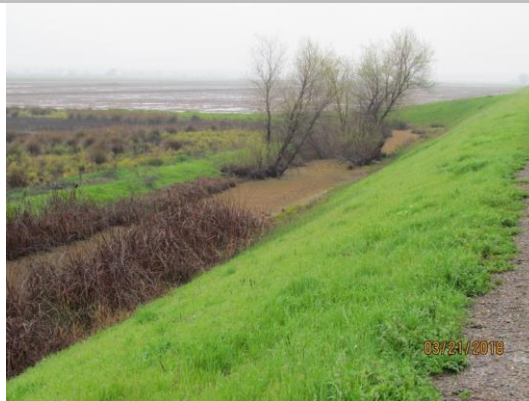
Photo 1 of 1 : SP_2019_RD0784_182_9_20190305_00002.jpg

View of landside looking downstream at the ditch that is along the levee toe.

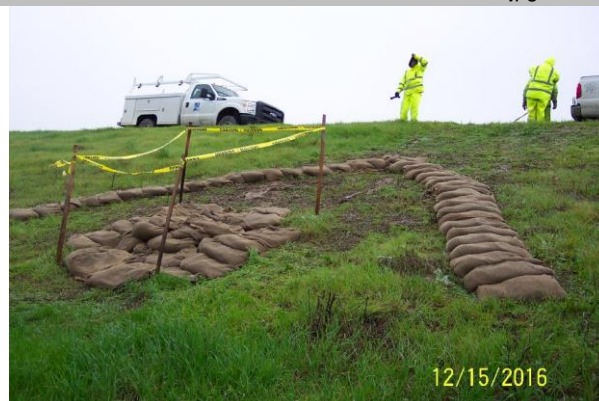
Photo 2 of 3 : UCIP_SP_2019_53540_76309.jpg

11/30/2017 - same as previous inspection - crossing remains Urgent. Received updated photos from DWR levee inspector, S. York, showing current condition of levee LS and WS. (O. Magana - DWR UCIP)

WS view: Sink hole filled in with sandbags and "V" shaped diversion dam built to help divert rainwater.

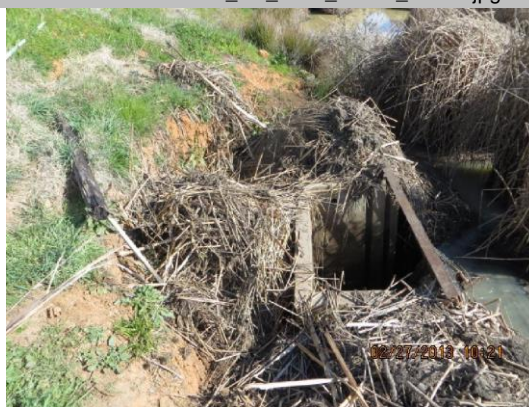
Photo 3 of 3 : UCIP_SP_2019_53540_54254.jpg

Erosion and debris from Beaver activity.

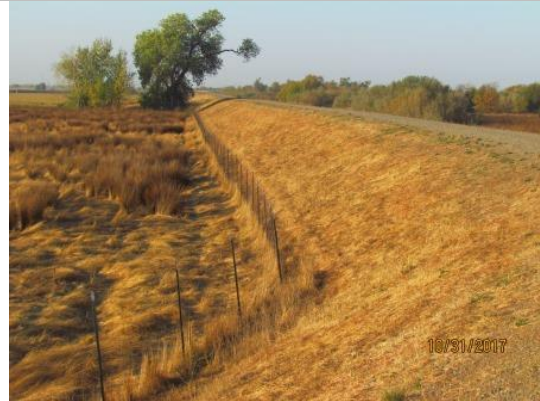
Photo 1 of 1 : SP_2019_RD0784_182_5_20190305_00001.jpg

View of fence along the landside toe looking downstream.

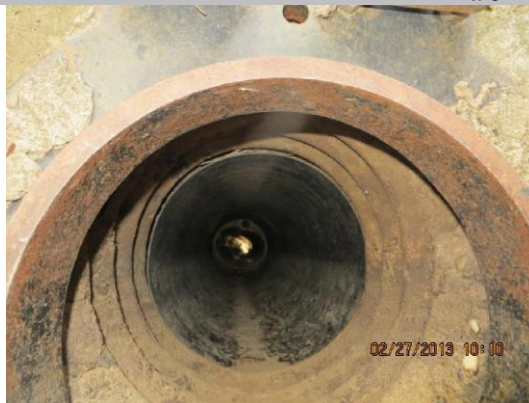
Photo 2 of 3 : UCIP_SP_2019_53553_54262.jpg

Pipe showing sliplined PVC insert. some erosion of PV at outlet and it may be disjointed internally.

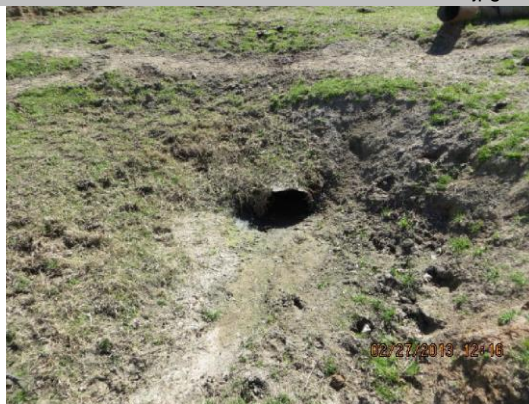
Photo 2 of 3 : UCIP_SP_2019_53542_54268.jpg

Partially clogged inlet pipe at LS toe.
